MARINE INVESTIGATION REPORT
M02L0021

HULL FRACTURE

BULK CARRIER *LAKE CARLING*
GULF OF ST. LAWRENCE, QUEBEC
19 MARCH 2002

Report Number M02L0021

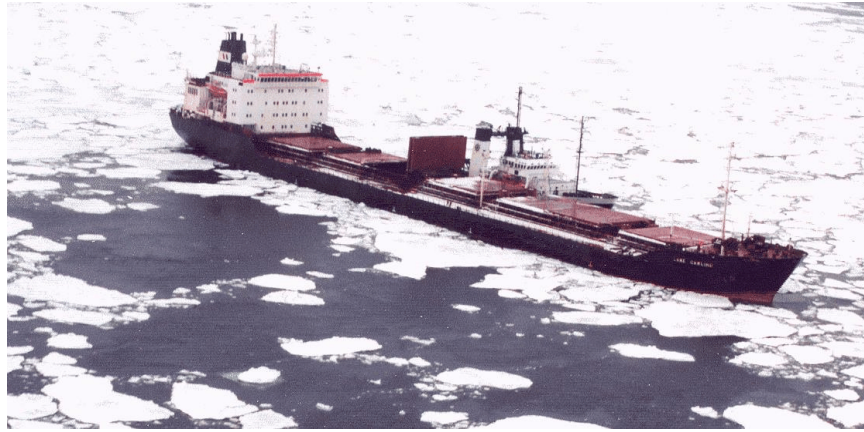
Photo 1. The *Lake Carling* stopped in ice, 22 March 2002 (assisting tug, the *Ryan Leet*, seen on the port side)

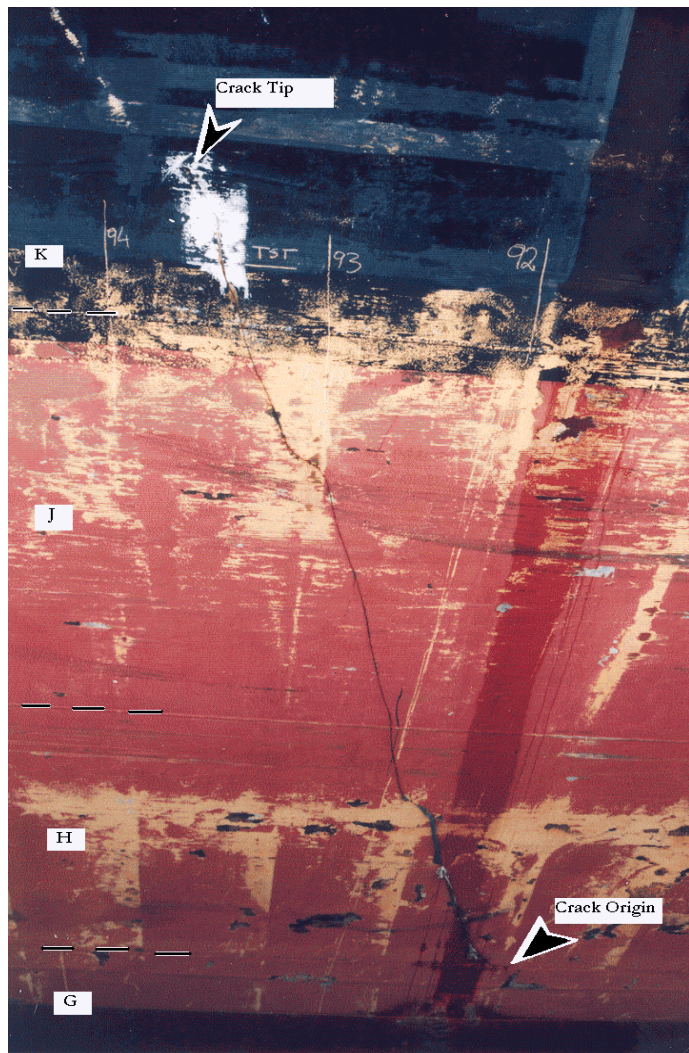
Photo 2. Principal fracture

The fracture had not grown appreciably since the initial discovery, as a crack-arresting hole had been drilled at the crack tip to limit the growth of the fracture.

The principal side shell fracture was on the port side at frame 91, extending upwards and forward from the toe of the weld at the base of the side shell frame. The fracture traversed frames 92 and 93 through H and J strakes, terminating just short of frame 94 (K strake) in No. 4 upper water ballast tank, which was empty at the time. The shell fracture divided at the juncture of the ballast tank sloping plate; one branch continuing for 45 centimetres (cm) on the ballast tank sloping plate at approximately 90° from the juncture point—the other branch on the ship's side continuing up and forward for approximately 40 cm past the juncture point. The total length of the fracture at the ship's side was in the order of 6 m. Visual inspection and laboratory analysis indicates that the principal fracture originated at the base of frame 91 (at the toe of the weld).⁴ The fracture origin was located 1.3 m below the neutral axis of the vessel's midship section modulus.

- the change in plate thickness at the shell plate.
3. The relatively low fracture toughness of the side shell plate when exposed to near 0° C temperatures allowed the forward crack at frame 91 (port) to grow to failure at a load well below the ultimate tensile strength of the material. The length of this crack at the time it became critical was not determined but could have been as short as 10 cm.

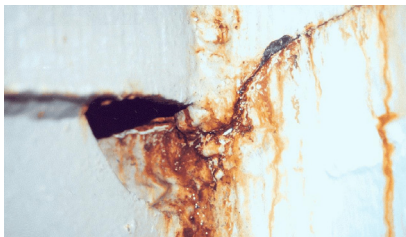
The principal fracture was the forward half of a crack manifestation that presented itself on either side of the base of the frame. Five similar crack manifestations were found in No. 4 hold; on the port side, at frames 89 and 93, and on the starboard side, at frames 85, 91 and 96. All crack manifestations appeared to originate near the base of the frame at the toe of the weld, and giving rise to two cracks, one forward and one aft of the frame, each some 75 millimetres (mm) in length and generally in a characteristic "V" formation. Some typical examples found on the port side are shown below (See Photos 3, 4 and 5). All of these cracks were rusted and appeared to have been present for some time.

Photo 3. Frame 93

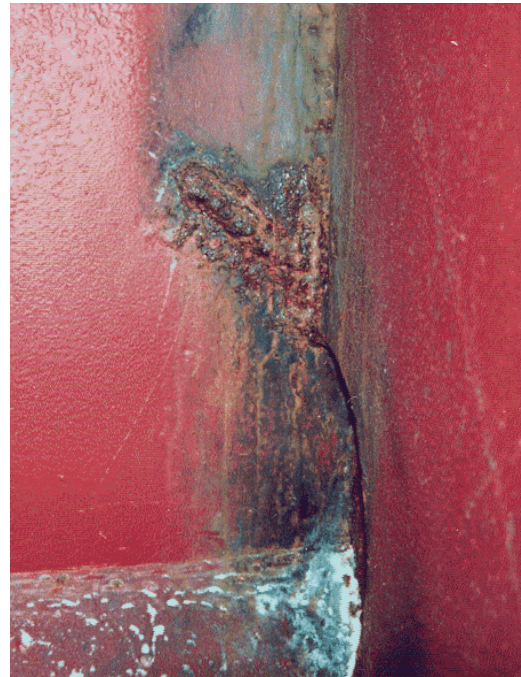
In No. 2 hold, four crack locations were also found; on the starboard side at frames 171½ (See Photo 6) and 172½, and on the port side at frames 144 and 145. In contrast to the cracks in No. 4 hold, all of the cracks in No. 2 hold had been covered with superficial weld repairs. The weld repairs had penetrated only a few millimetres into the thickness of the hull plate. It was not determined when, or by whom, these repairs were undertaken, nor is there any record held by DNV of these cracks or the repairs. In contrast to the crack manifestations in No. 4 hold, not all of these cracks were present both fore and aft of the frame, such as at frame 171½, where the crack was only forward of the frame.

Photo 6. Frame 171½ starboard

All four of the cracks in No. 2 hold were superficially repaired and only one frame had been replaced at the Gdansk drydock. Another major difference is one of construction detail. All of the frames of concern in No. 4 hold are of the separate bracket configuration while those in No. 2 hold are integral brackets. The stress concentration factors, such as the discontinuities caused by the scallop (cut-out) in the side frame and the proximity to the change in plate thickness at the shell plate seam weld, are not entirely similar.
